AUTO SAFETY HOTLINE (800) 424-9393 Wash. D.C. Area 366-0123 Case Veh. (A): 1998 Plymouth

Type: Neon, 4-door sedan Driver: 31-year-old female

CDC: 12-FYEW-3

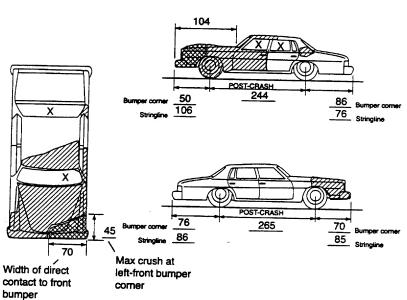
(Slide 4) Damage to case vehicle (A) was moderate. (Slide 5) Direct damage began at the left-front bumper corner and extended 70 cm to the right, resulting in a vehicle overlap of 49 percent. (Slide 6) The maximum crush was 45 cm at the left-front bumper corner.

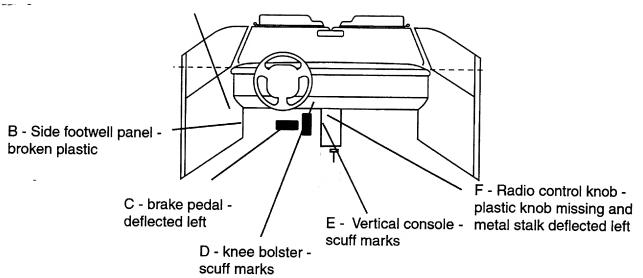
VEHICLE OCCUPANT CONTACT DIAGRAM

Confidence
	Interior	Occupant	Body		Level of
	Component	No. if	Region		Contact
Contact	Contacted	Known	if Known	Supporting Physical Evidence	Point
Α	Lt. door	Driver	Left thigh	Bowed outward	1
	Footwell	Driver	Lt. leg	Cracked and broken plastic	1
В	panel				
С	Brake pedal	Driver	Rt. ankle	Deflected left	1
D-	Knee bolster	Driver	Rt. leg	Scuff mark	1
_	Vertical	Driver	Rt. leg	Scuff mark	1
E	console				
_	Radio knob	Driver	Rt. leg	Plastic knob knocked off and	1
F				metal stalk deflected left	
G					
Н					
1					
J

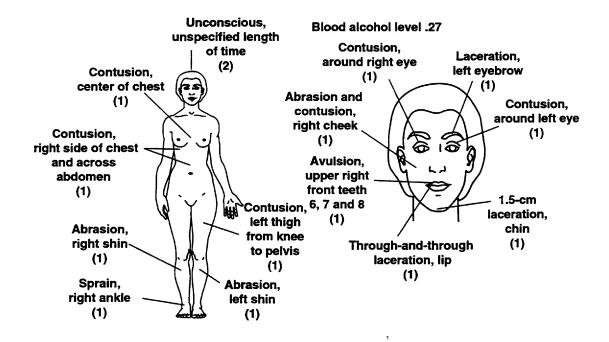
INDICATE LOCATION OF INJURIES.

Injury Source		
Injury Description	A.I.S.	Definite	Probable	Possible
Laceration, left eyebrow	1		Eyeglasses (airbag interaction)	
Contusions, around right and left eyes	1		Eyeglasses (airbag interaction)	
Abrasion, right cheek	1		Airbag	
Contusion, right cheek	1		Airbag	
Unconscious, unknown length of time	2		Side-door interior surface	A-pillar
Avulsion, upper right front teeth 6th, 7th and 8th	1		Side-door interior surface	A-pillar
Through-and-through laceration, lip	1		Side-door interior surface	A-pillar
1.5-cm laceration, chin	1		Side-door interior surface	A-pillar
Contusion, center of chest	1		Airbag	
Contusion, right side of chest	1		Airbag	
Contusion, across abdomen	1		Lower steering-wheel rim	Airbag
Contusion, left thigh from knee to pelvis	1		Side-door interior surface

Injury Source	
Injury Description	A.I.S.	Definite	Probable	Possible
Abrasion right shin	1		Knee bolster	Vertical console/radio control knob
Abrasion, left shin	1		Side footwell panel	
Sprain, right ankle	1		Brake pedal	Toepan
Blood alcohol level .27				
Maximum A.I.S. Level	<u>2</u>			
Injury Severity Score	<u>6</u>
